# MUN Evaluation in Ag Drains Summary to Date

### Sacramento Valley Archetypes

Colusa, Live Oak, Willows, Biggs Sampling period: April – June 2012 Quarterly Review in July 2012

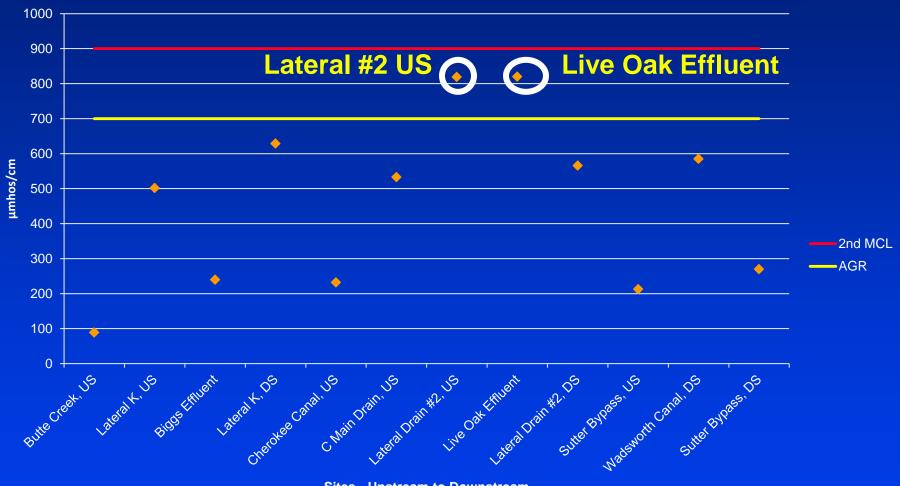
# **East Side - Sutter Bypass Specific Conductivity**

**Sites - Upstream to Downstream**

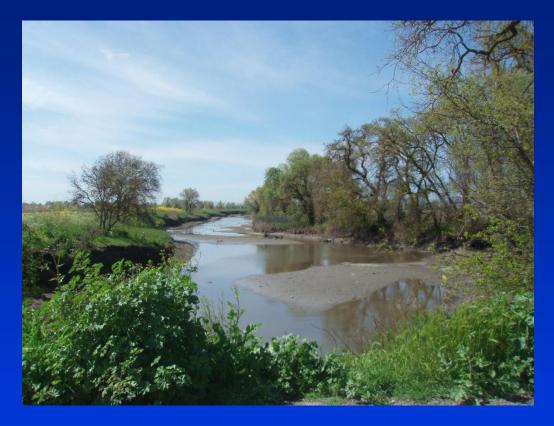
Powell Slough, Upstream of Unnamed tributary. Picture is looking downstream

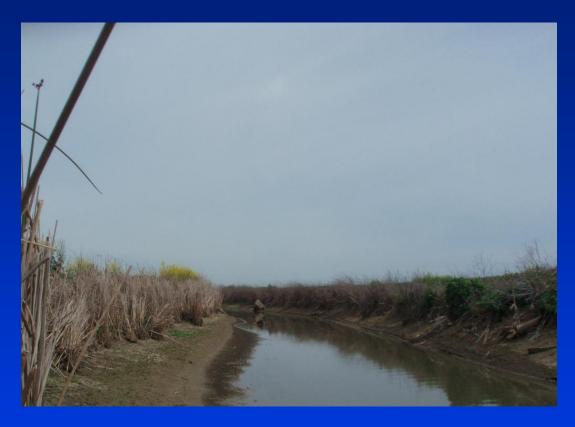
Ag Drain C at Road 60, before water enters Wildlife Refuge. Looking upstream

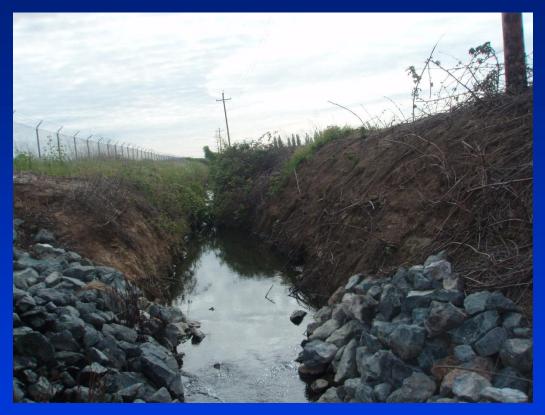
Lateral Drain #2, downstream of effluent. Looking upstream

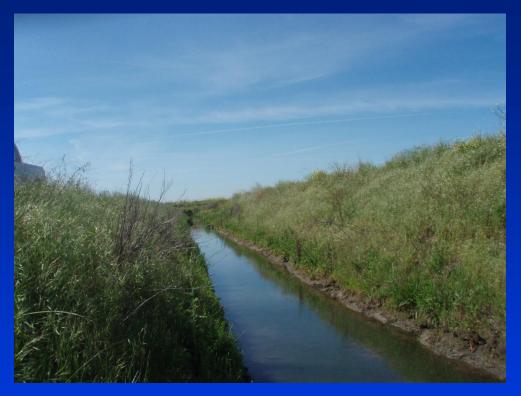
Lateral K, upstream of effluent discharge. Looking downstream
